EXHIBIT B –
Declaration of
Amy Katherine Taylor

Case No. 6-22-cv-00028-NKM

DECLARATION OF AMY KATHERINE TAYLOR

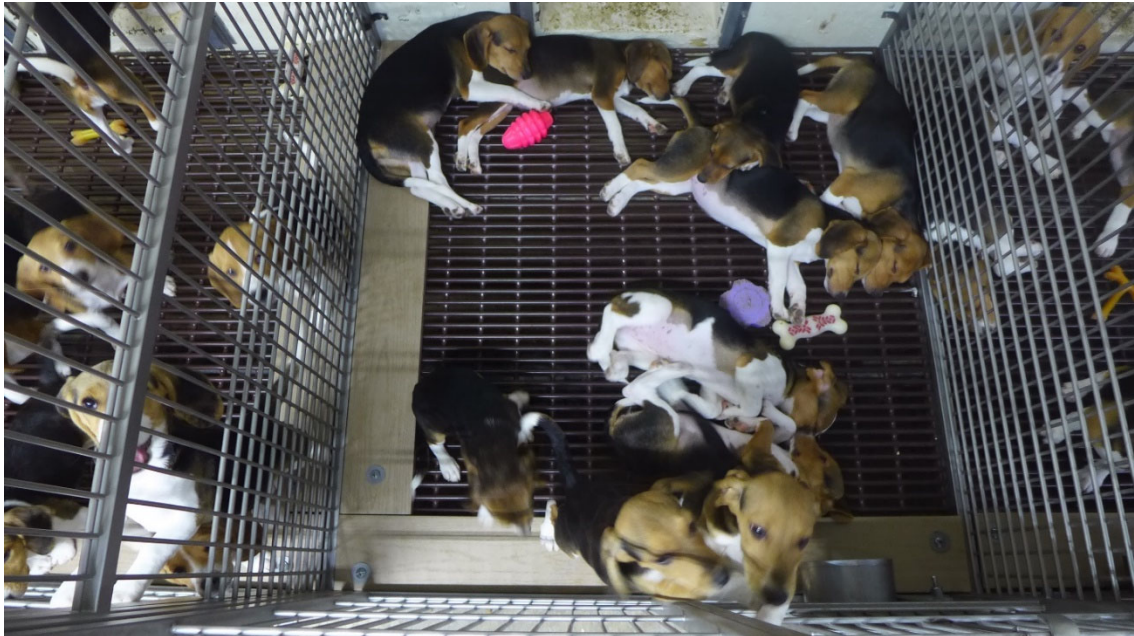
4. I observed that there were enclosures with numerous animals in them, and that there were enclosures that contained nine or more dogs. *See photo below.*

For example, enclosures 9A102, 9A103, 9A105, 9A106, and 9A107 all had 10 dogs in them, and enclosures 9A124, 10A16, 10A23, 10A24, and 10A25 had 9 dogs in them. In many enclosures, I observed that one beagle would be hunched in the corner in a manner that indicated it was overwhelmed.

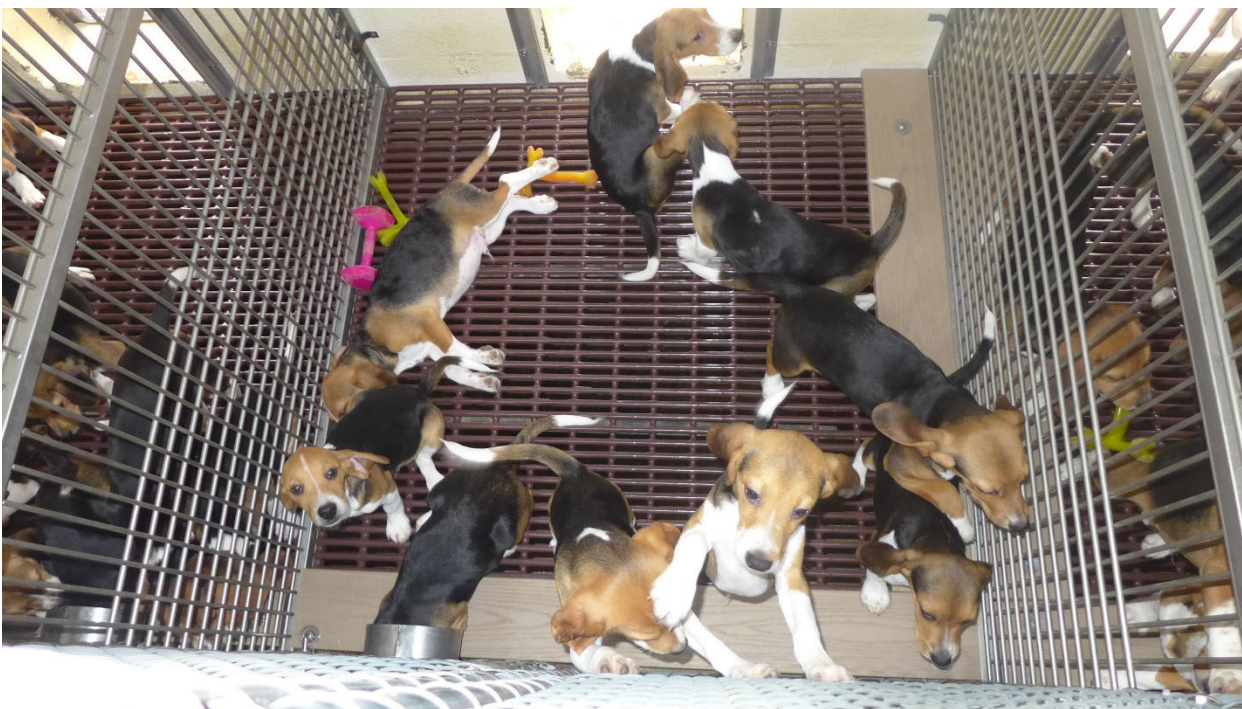
7. Each enclosure only had one food receptacle, which allowed only one dog to access the food at a time. *See* photo (The feeder is at the bottom left corner of the enclosure at the bottom of the page. The photo shows one beagle eating from the feeder.). I saw multiple beagles exhibiting behavior indicative of resource guarding in front of the feeders.

For example, I observed dogs laying in front of the feeder with their head in the feeder and, when another beagle would approach the feeder to attempt to eat, the dominant beagle would start to growl.

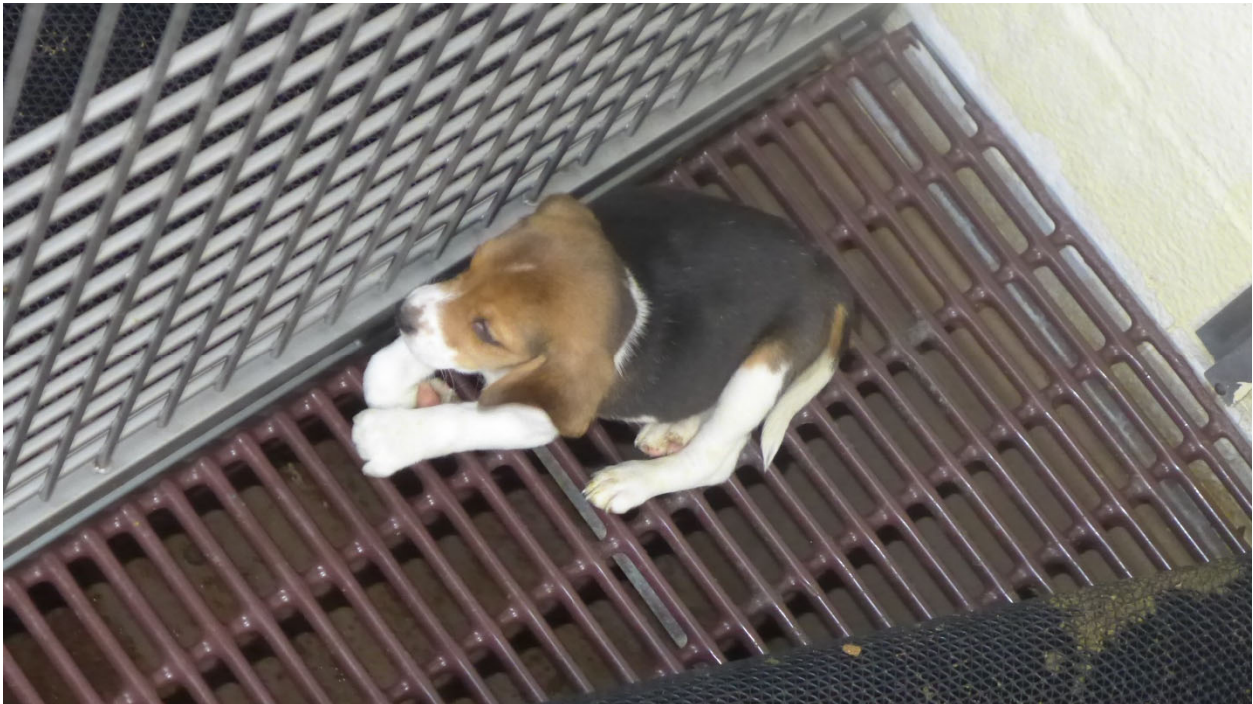
14. The flooring in the enclosures were made of grates, and allowed for the feet and toes of the beagles to slip in through the grates. The building that contained the nursing mothers and their babies contained black rubber mats on top of the grated flooring, and in more than 12 separate enclosures I saw that the black mat had shifted and moved in a way that exposed the grated flooring underneath. *See photo.*

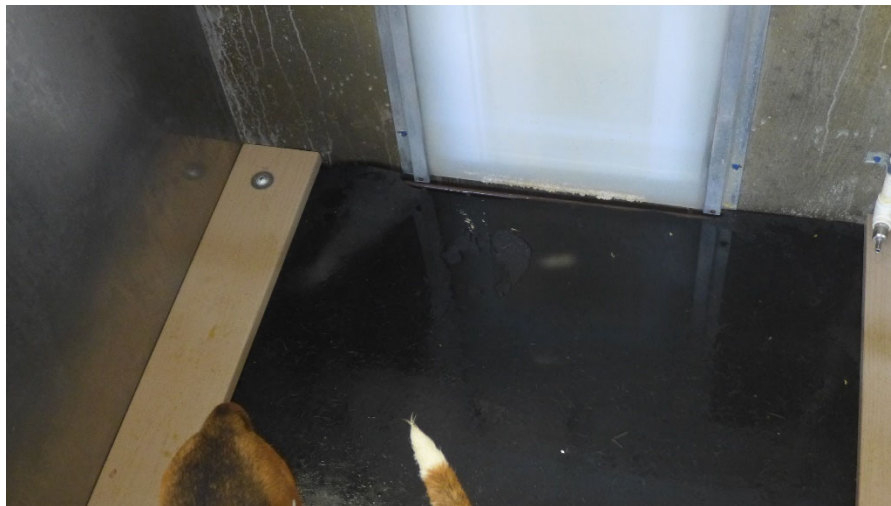
I personally observed that in some enclosures where the mats had been installed, beagles were standing in their own urine and feces. *See* photo below (beagle standing in urine).
